**MINUTES
BURKE COUNTY BOARD OF COMMISSIONERS
SPECIAL MEETING**

BURKE COUNTY, NORTH CAROLINA

PROPERTY BOOK

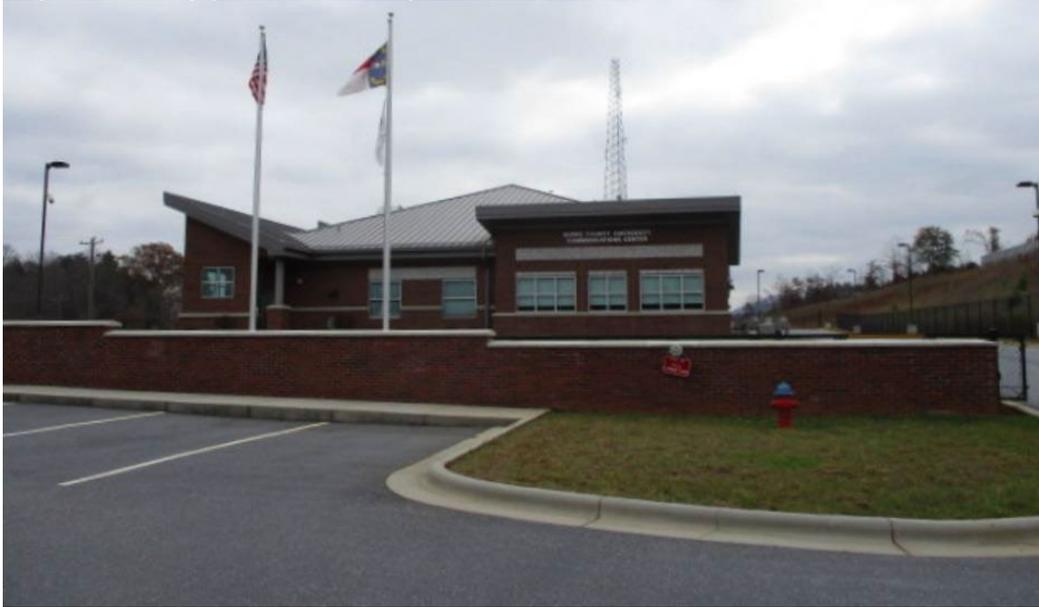
Name of Building: 911 Call Center

Overall Building Condition: Good

Known issues: Needs a backup generator
Connection and communication tower
Grass around tower

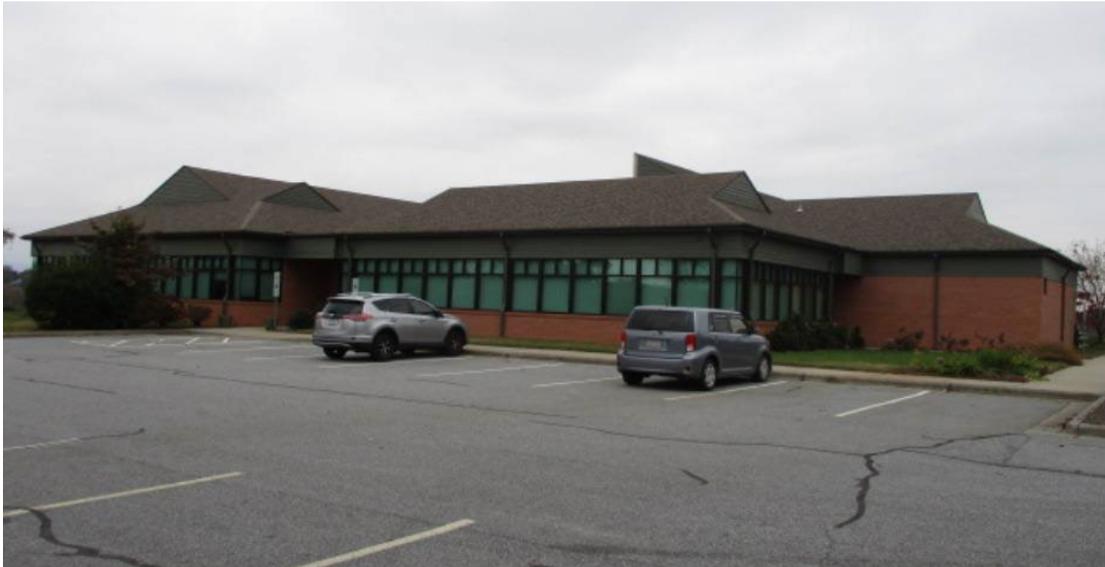
Name of Building: Agricultural Extension Service
Address: 130 Ammons Dr.
Morganton, NC
REID # 55199 PIN # 2702580688

| Building Name | Condition | Known Issues |
|---|---|---|
| Agricultural Extension Service | Good | <ul style="list-style-type: none"> • Need one (1) roof-top HVAC replaced immediately • Emergency lights do not work • Exterior trim repair • Roof needs to be replaced within the next five (5) years • Pavement needs to be resurfaced |

Overall Building Condition: Good

Parking lot condition: Pavement needs resurfaced

Known issues: Need 1 roof-top HVAC replaced immediately
Emergency lights don't work
Exterior trim repair

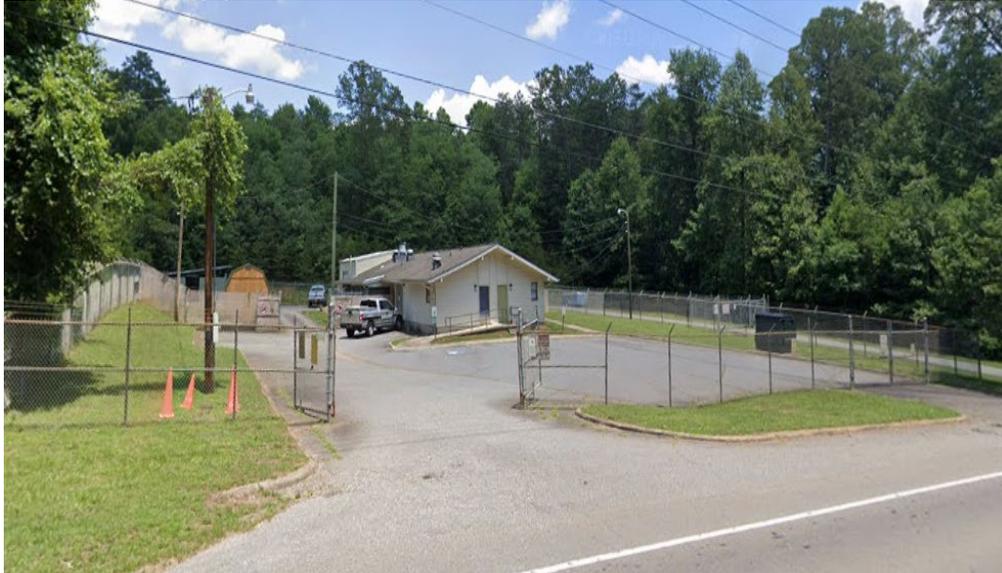
Name of Building: Animal Services
Address: 425 Kirksey Dr.
Morganton, NC
REID # 38036 PIN # 2704945039

| Building Name | Condition | Known Issues |
|---|---|---|
| Animal Services | Poor | <ul style="list-style-type: none"> • Underground plumbing is inadequate • Roof in poor condition (two (2) years until complete deterioration) • Needs assessment was recently completed |

Overall Building Condition: Poor

Known issues: Underground plumbing inadequate
Roof in poor condition
Needs assessment

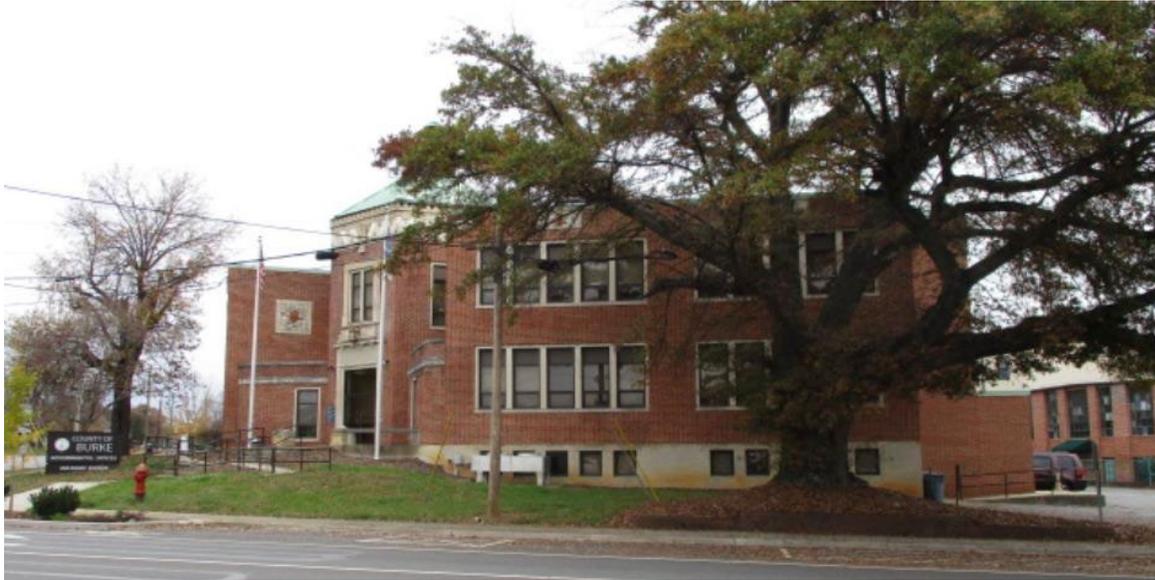
Name of Building: Avery Building

| Building Name | Condition | Known Issues |
|---|---|---|
| Avery Building | Average/Poor | <ul style="list-style-type: none"> • Windows and front doors need to be replaced • No access control for security • Front access to street and parking is dangerous, does not meet ADA requirements • Exterior needs cleaning and repairs • Parking lot needs to be resurfaced |

Overall Building Condition: Average/Poor

Known issues: Windows - need replacing
Doors - replaced - front
No access control on security
Front access to street and parking is dangerous, doesn't meet ADA
Exterior needs cleaning, repairs

| Building Name | Condition | Known Issues |
|---|---|---|
| Discussion ensued on the Avery building's lack of security features and ADA requirements. Mr. Champion recommended hiring a consultant to evaluate the building/codes to get a cost analysis to repair the building and ensure everything meets ADA requirements. | | |

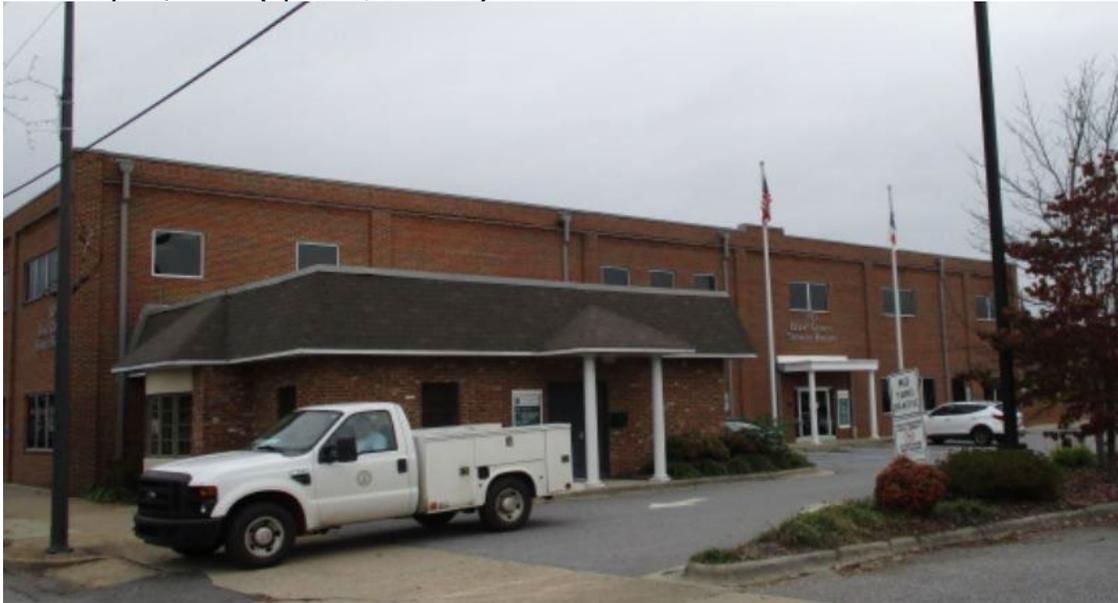
| Name of Building: | <u>Burke Services</u> |

| Known issues: | <u>Roof leaks</u> |
| | <u>HVAC system needs repairs and replacement</u> |

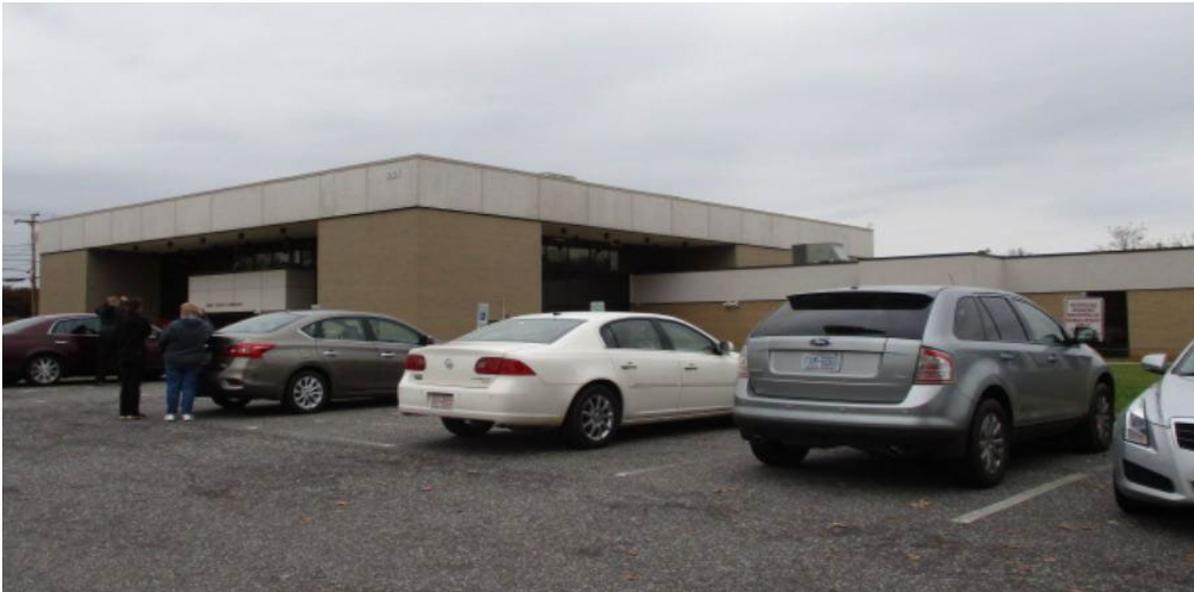
Name of Building: Courthouse

| Courthouse | Average | <ul style="list-style-type: none"> • Front automatic doors - replace controls • Major plumbing work needed in the jail holding cell area • Masonry in front areas need replacing • HVAC units should be okay for the next five (5) years utilizing regular maintenance • Lights (interior & exterior) need replacing • Misc. exterior painting, cut & replace trees • Paint entire interior |

Known issues: Front automatic doors - replace controls
Major plumbing work needed in Jail holding cell area
Masonry in front areas need replacing
Several HVAC units need replacing
Lights(interior & exterior) need replacing
Misc. exterior painting, cut & replace trees
Paint entire interior

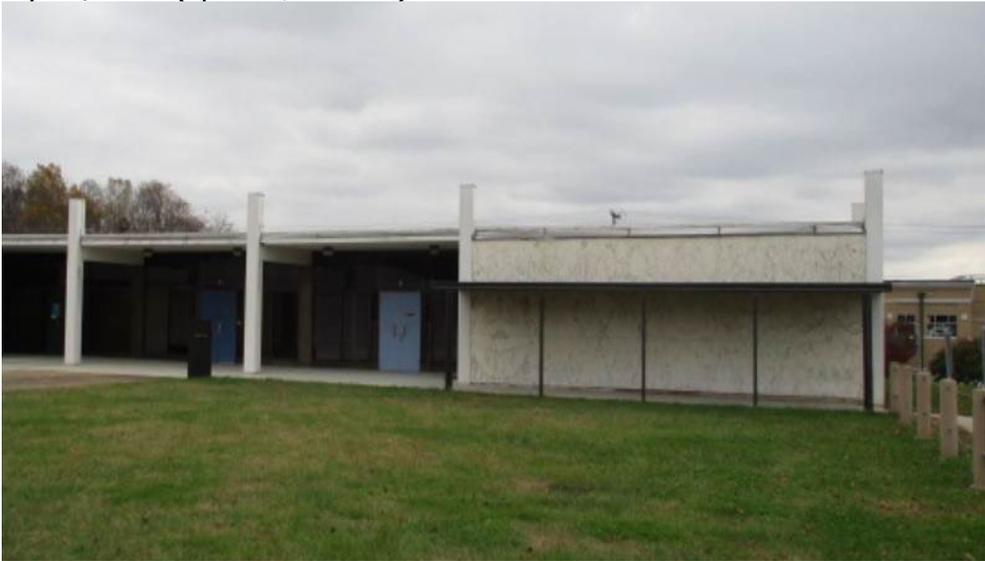
| Name of Building: | <u>Courthouse Annex</u> |

| Known issues: | <u>Needs interior and exterior paint</u> |

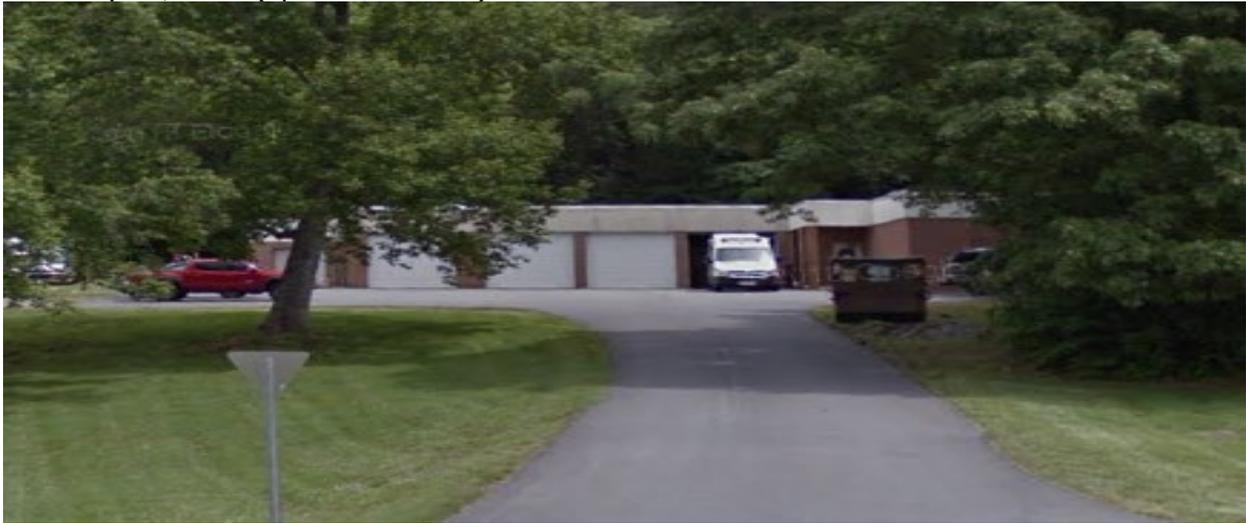
| Name of Building: | Burke EMS Station 1 |

| Building Name | Condition | Known Issues |
|--|---|--|
| EMS Station 1 | Poor | <ul style="list-style-type: none"> • Building electrical panel is full • Building needs upgrades (baths, kitchen, electricity) • No backup generator • Has many general repair needs • Not on city sewer (\$15,000 for County to tap into the sewer line itself) • Bays are short and building height is low for ambulances • Needs a new gutter on back of the building |
| <p>Mr. Champion said this is one of the worst buildings in the EMS base category because of a failed septic tank and parking on the drain field, which requires routine pumping. County Manager Steen noted that the hospital owns the building, but the County maintains it, discussion ensued on the septic system, the lease and potential impact to other contractual obligations with the hospital. Chairman Carswell asked if the County owns any land nearby that a new EMS base could be constructed on, discussion ensued. The Manager advised that the location of this base may not be as advantageous as it once was given the locations of the new EMS bases. He was asked to begin looking for other properties.</p> | | |

| Known issues: | Building electrical panel is full Building needs upgrade (baths,kitchen, elect) No back up generator Has many general repair needs Not on city sewer Bays are short and buidling height is low for ambulances |

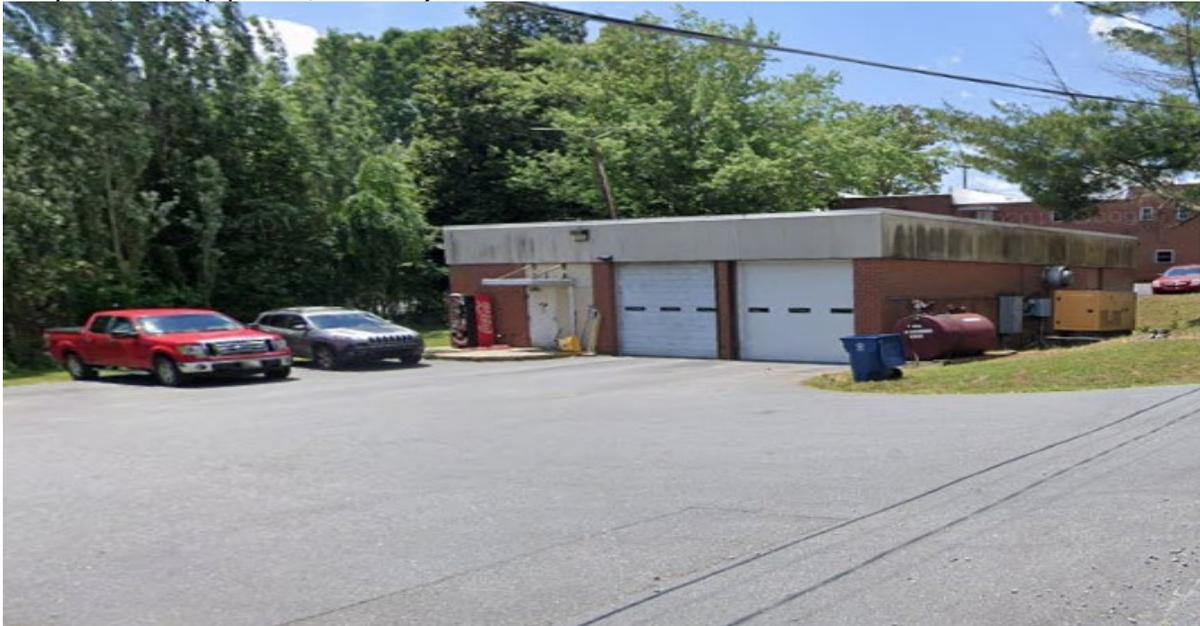
| Name of Building: | Burke EMS Station 2 |

| Building Name | Condition | Known Issues |
|--|---|--|
| EMS Station 2 | Poor | <ul style="list-style-type: none"> • Windows need to be replaced with insulated windows • Building needs upgrades (baths, kitchen, electric) • Grade/water issues around the outside • Has many general repair needs • Exterior/bays needs painting • Bays are short and building height is low for ambulances • Bay door 2 needs upgrading • Street trees need to be removed • Roof needs to be replaced in 10 years • Fuel tank needs to be replaced in five (5) years |

| Known issues: | Windows need replaced with insulated windows Building need upgrade (baths,kitchen, electric) Grade/water issues around the outside Has many general repair needs Needs painting exterior/bays Bays are short and buidling height is low for ambulances Bay door needs upgrading #2 |

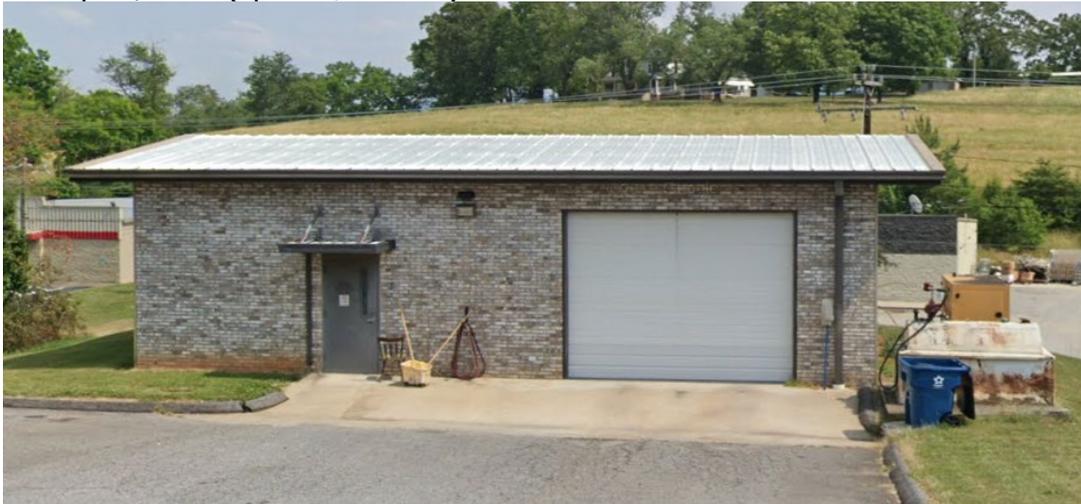
Name of Building: Burke EMS Station 3

| Building Name | Condition | Known Issues |
|--|---|--|
| EMS Station 3 | Average | <ul style="list-style-type: none"> • Needs new floor and ceiling tiles • Roof needs screws replaced • Rat or mole infestation around foundation • Heat and A/C is old • Need to replace electric bay heat with gas • Needs gutter drain on front entrance • Parking lot needs to be repaved soon • HVAC needs to be replaced in five (5) years |

Known issues: New floor tiles and ceiling tiles
Roof needs screws replaced
Rat or Mole infestation around foundation
Heat and A/C is quite aged
Need to replace electric bay heat with gas
Needs gutter drain on front entrance

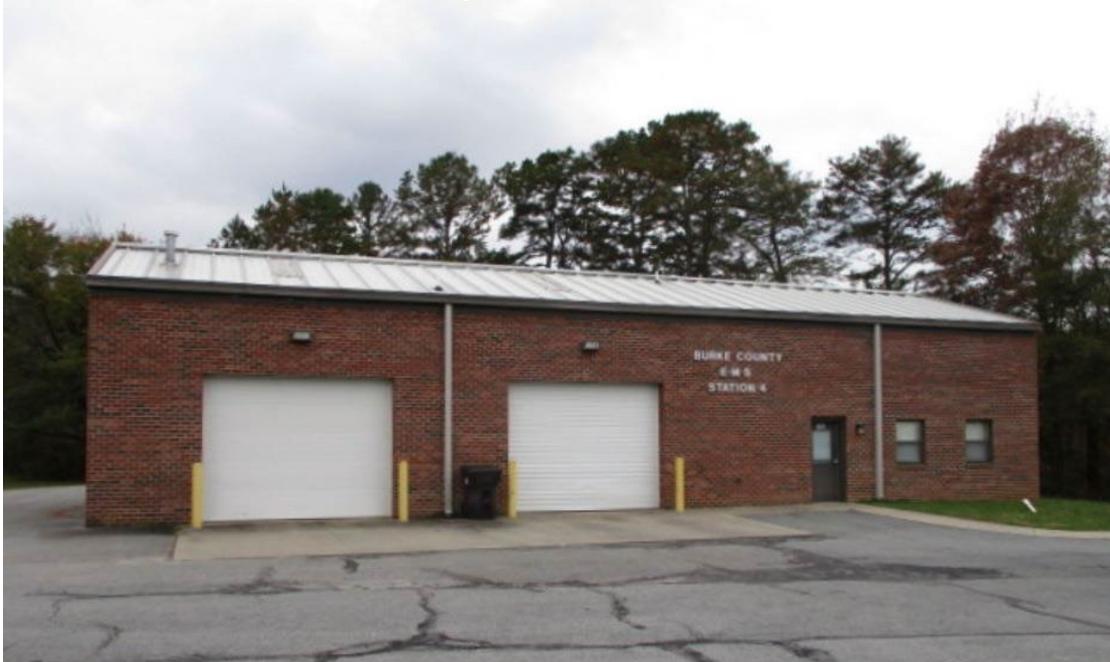
Name of Building: Burke EMS Station 4

Known issues: New floor tiles in bathroom
Drains for gutters (foundation staying wet)
Replace garage door door #2
Replace garage door motor #4
Paint inside bays
Several general repairs needed
Hot water heater needed soon

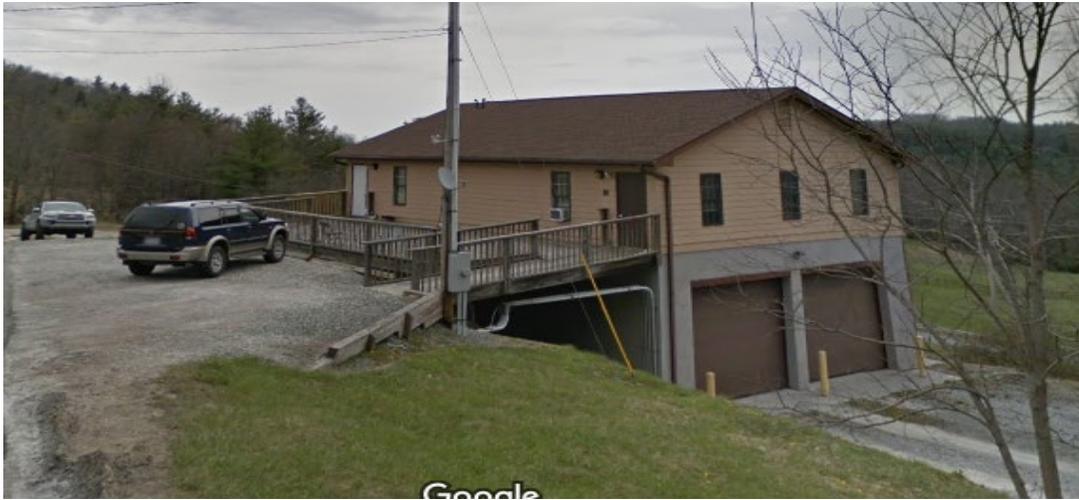
Name of Building: Burke EMS Station 5

Known issues: Bay cabinets are just not designed for that area.
Needs grass established

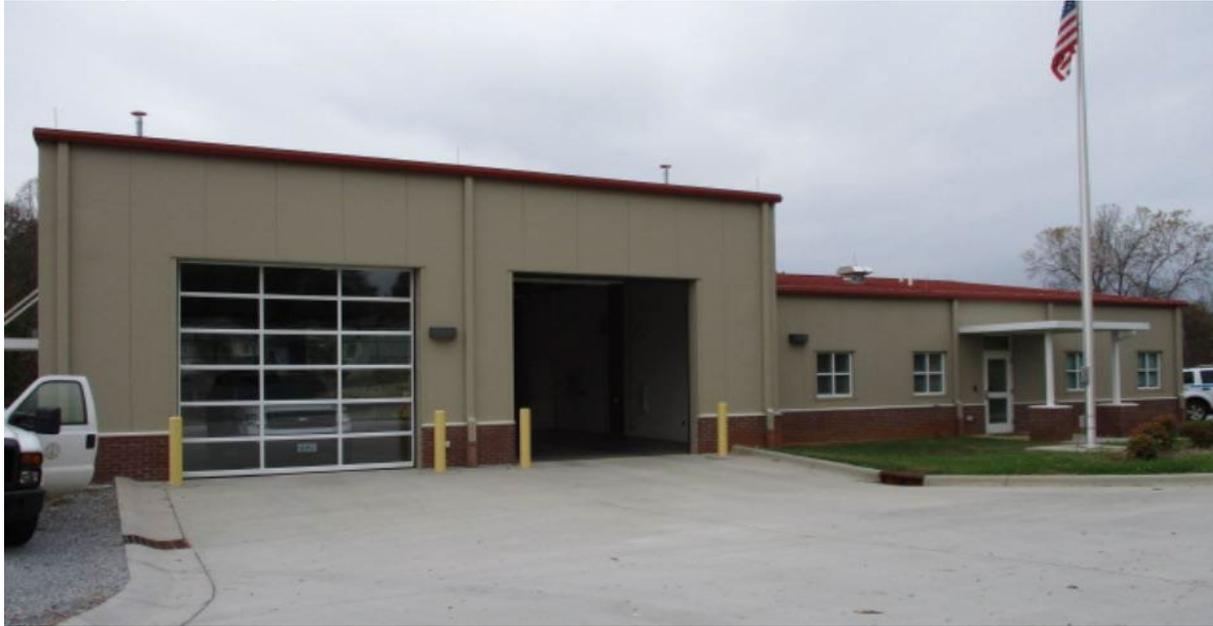
Name of Building: Burke EMS Station 7
Address: 615 N College st
Morganton, NC 28655
REID # 38112, PIN # 1793983158

| EMS Station 7 | Good | <ul style="list-style-type: none"> • Two (2) – three (3) general maintenance issues • Lights in bay area are out • Gutter leak in front at the office • Hurricane room needs the door lock mechanism replaced • HVAC needs preventive maintenance |

Known issues: 2-3 general maintenance issues
Gravel drive around side of bldg. needs paving
HVAC
Lights in bays area out
Gutter leak in front at office
Hurricane room- replace door lock mechanism

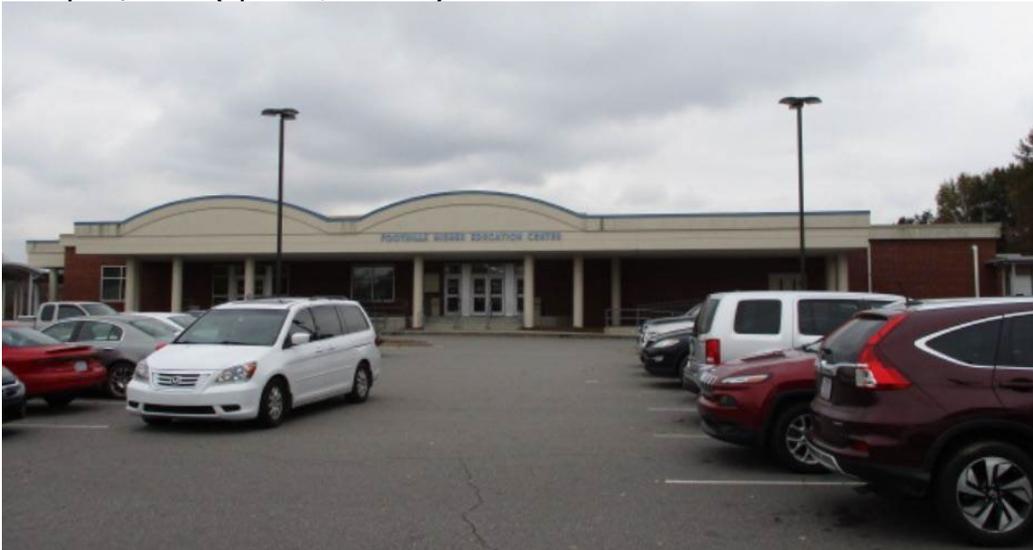
| Name of Building: | <u>Foothills Higher Education Center</u> |

| Foothills Higher Education Center | Good | <ul style="list-style-type: none"> • Some HVAC units need to be replaced • Door hardware (interior panic bar) is worn out and needs replacement soon • Stormwater issues along the east side • Review the roof in five (5) years and replace at 10 years • Look at replacing HVAC systems in five (5) years |

| | <u>Stormwater issues along east side</u> |

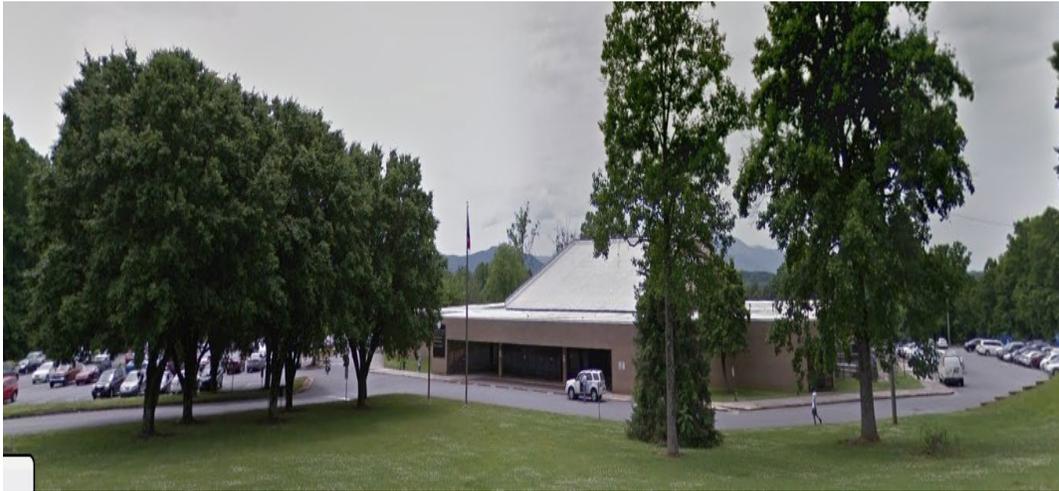
| Name of Building: | <u>Human Resources Center</u> |

| Human Resources Center | Average/Poor | <ul style="list-style-type: none"> • Replace all parking lighting and wall packs • HVAC controls need to be overhauled – number one priority • Interior paint • Partial roof replacement, glass roof leaks • Lobby ceiling is falling • Elevator never updated |

| <p>Mr. Champion said in addition to the age of the building, the most significant issue with the Human Resources Center (HRC) is that the building is extremely overcrowded which causes a tremendous strain on the utilities and General Services, at least once a day (sometimes more), has to reset the electricity breakers. Discussion ensued regarding the problems with the HVAC system; Mr. Champion noted that past General Services employees made temporary fixes which are no longer working for the facility. Commissioner Brittain said during his time on the DSS Board, he has heard staff make statements that indicates no one cares or they feel abandoned in that building because they submit so many work orders that go unfulfilled due to the lack of maintenance personnel. Mr. Champion said at one point there was a full-time maintenance employee at the HRC, but they have since been reassigned. He noted that General Services staff are at the HRC almost daily working on the facility. Discussion ensued regarding HVAC issues, whether the County should continue to try and repair the ageing building vs. building/finding a new facility, capacity of the building for employees and the public, and the parking lot. Mr. Champion noted his staff are constantly repairing plumbing fixtures because people use their feet to flush toilets which breaks the plumbing/seals. So a legitimate decision about the building and its future can be made, Chairman Carswell said an in-depth study needs to be compiled to determine the true scope of the repairs needed, the estimated repair cost as well as the true capacity of the building, utilities and parking lot for employees and visitors. He said the County may need to hire a consultant to conduct the study, discussion ensued regarding lighting at the HRC.</p> | | |

| Known issues: | <u>Replace all parking lighting & wall packs</u> <u>HVAC controls need overhauled</u> <u>Interior paint</u> <u>Partial roof replacement, glass roof leaks</u> <u>Lobby ceiling is falling</u> <u>Elevator never updated</u> <u>Parking at capacity, trees overhanging</u> <u>Needs new signage</u> |

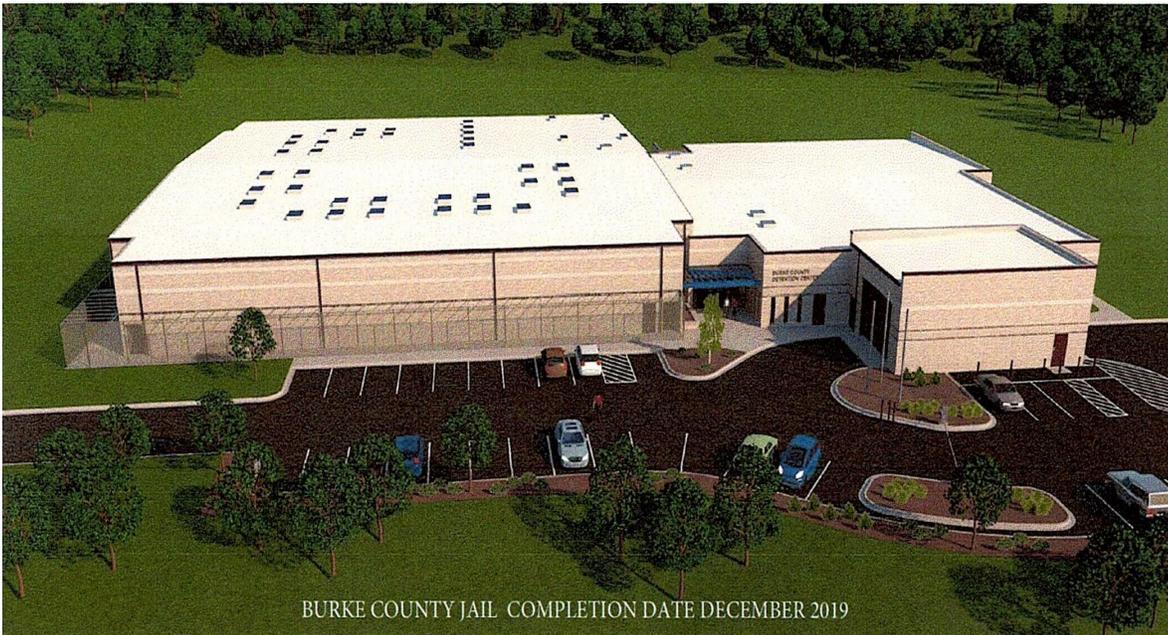
Name of Building: Jail

Known issues: Still under 1 year warranty
Open space under trees need debris removal,
minor grading, re-seeding

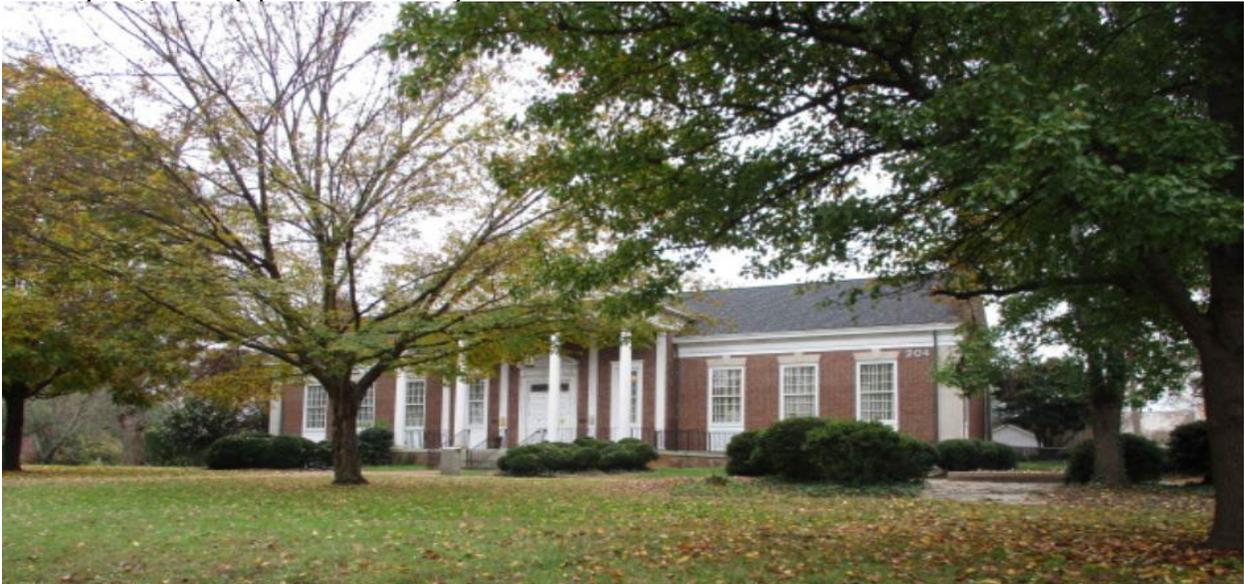
| Name of Building: | Morganton Public Library |

| | Per 2019 facility study renovation, cost estimated at \$10-12 million |

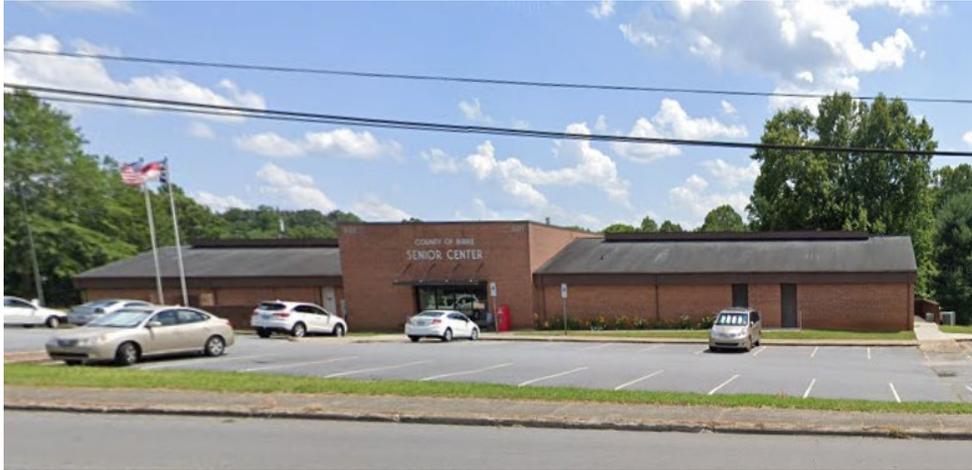
Name of Building: Morganton Senior Center

| Burke Co. Senior Center | Poor | <ul style="list-style-type: none"> • Water infiltration in basement • Re-roofing required • Facia needs replacing • Installation of walkway awnings • Main entrance doors need replacing • General exterior repairs • Remove large trees in rear |

Known issues: Water infiltration in basement
Re-roofing required
Facia needs replacing
Walkway awnings need installing
Main entrance doors need replacing
General exterior repairs
Remove large trees in rear

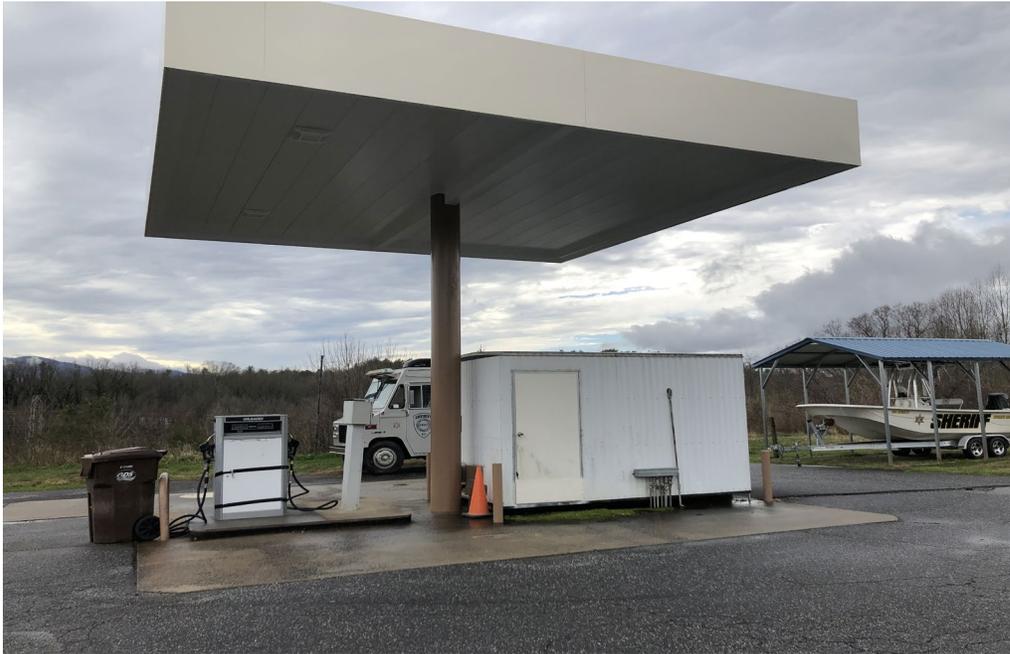
Name of Building: Gas Pump Building
Address: 148 Government Dr
Morganton, NC
REID # 38036 PIN # 2704945039

| Gas Pump Building | Average | <ul style="list-style-type: none"> • Exterior metal cladding coming loose • Pavement resurfacing needed |

Known issues: Exterior metal cladding coming loose
Pavement resurfacing needed
HVAC system needs repairs

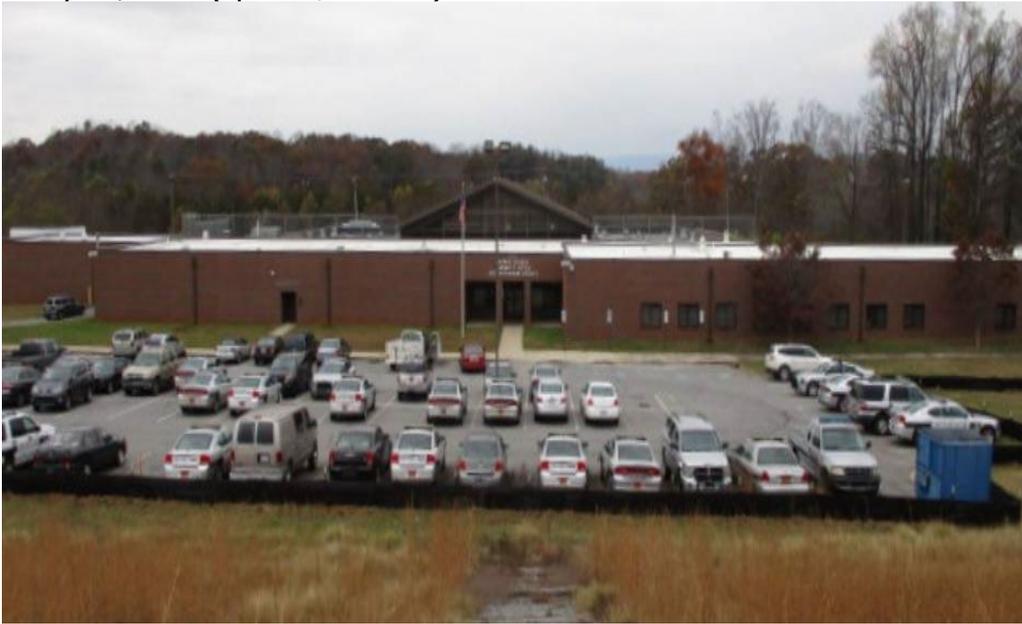
| Name of Building: | <u>Sheriff's Office / old BCDCF</u> |

| Building/Trail/Park Name | Condition | Known Issues |
|--|---|--|
| Sheriff's Office | Average | <ul style="list-style-type: none"> • HVAC units need replacing • Roof leaks (repair within three (3) years) • Needs interior paint and carpet • Needs pavement and resurfacing |

| | <u>Needs pavement resurfacing</u> |

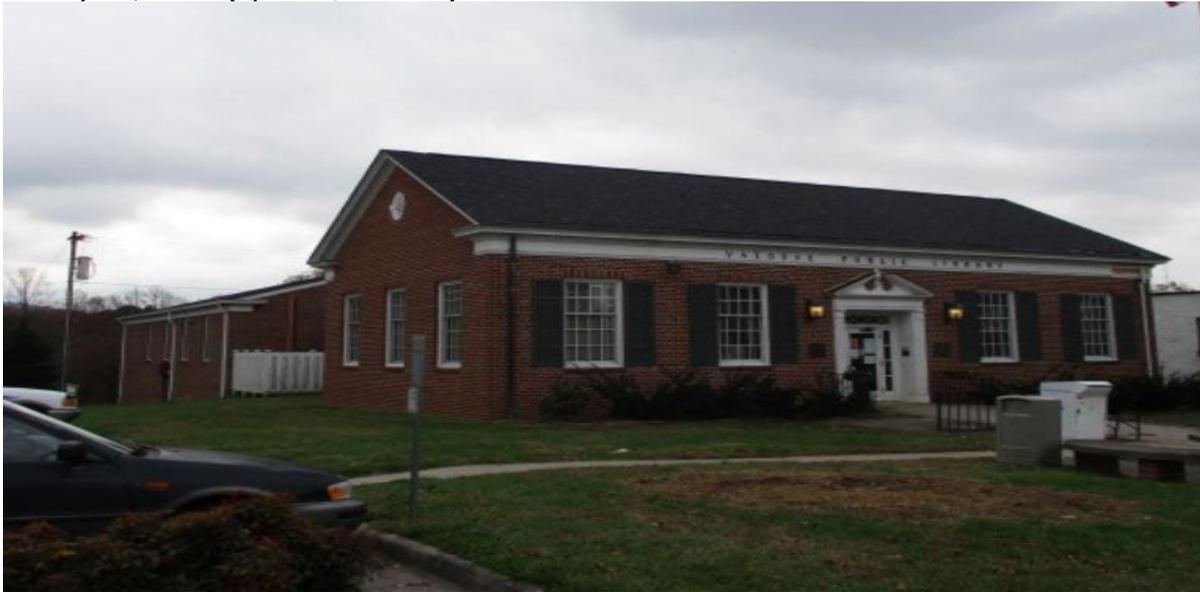
| Name of Building: | Valdese Public Library |

| Known issues: | 2014 HVAC needs replaced |

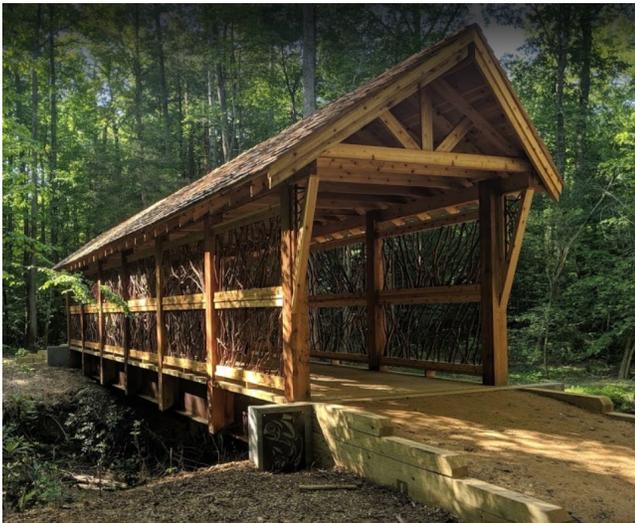
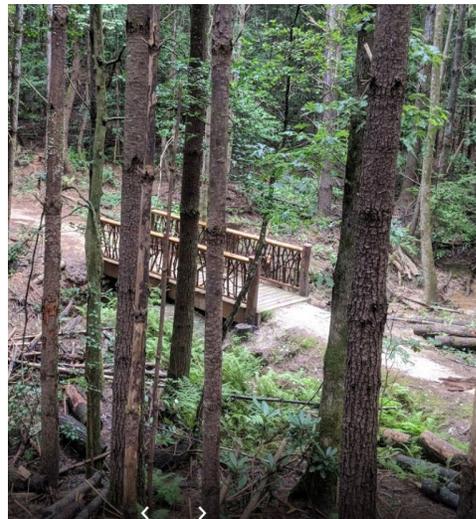
Name of park or trail area: Fonta Flora County Park and Trail

| Building/Trail/Park Name | Condition | Known Issues |
|--|---|--|
| Fonta Flora County Park and Trail | Good | <ul style="list-style-type: none"> • Need 16-foot bridge replacement due to fill/ erosion of abutments • Will need grading in 2022, approximately \$1.00 per foot. (\$25,000) |

Known issues: Lakefront area needs sand and .35 mile trail restoration
.

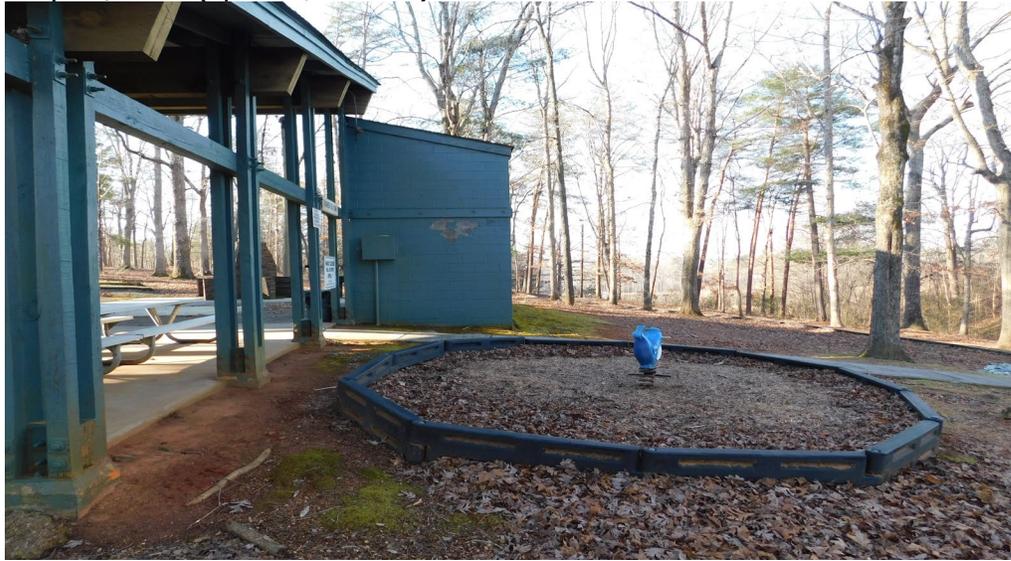
Name of park or trail area: Parker Rd. Park
Address: 700 East Parker Rd
Morganton, N.C. 28655

| Building/Trail/Park Name | Condition | Known Issues |
|--|---|--|
| Parker Road Park | Structures (poor) Trails (good) | <ul style="list-style-type: none"> • Park structures are in poor condition |

Known issues: Park structures are in poor condition

| Building/Trail/Park Name | Condition | Known Issues |
|--|---|--|
| Regarding the Parker Road Park, discussion ensued about tearing down the structures, due to their poor condition and potentially revitalizing the trail so employees and citizens can have a | | |

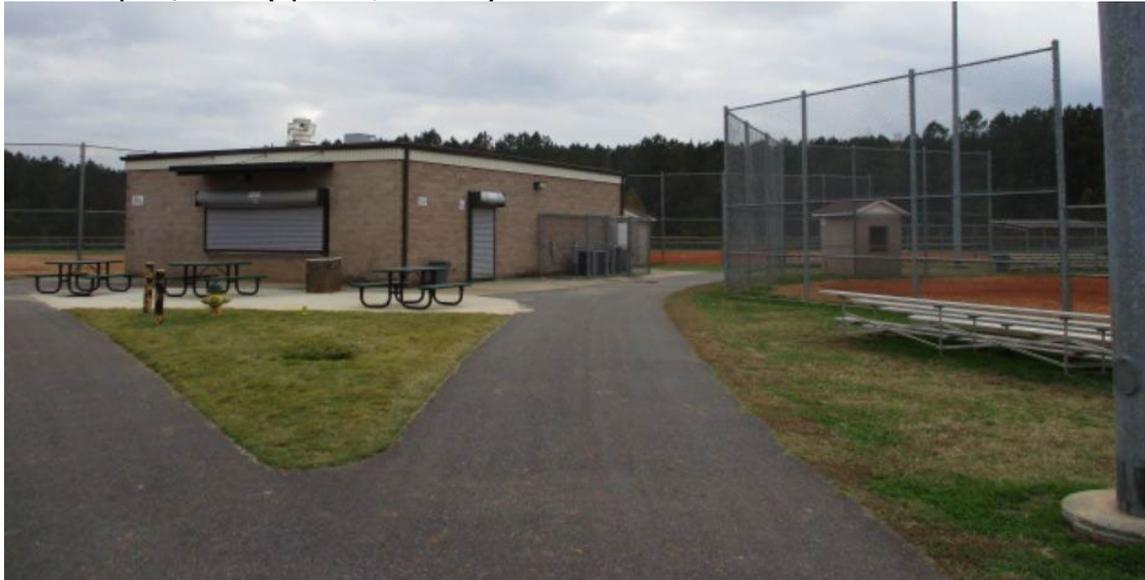
Name of park or trail area: Reep Park

Known issues: Need to finish lighting the other 2 ballfields.

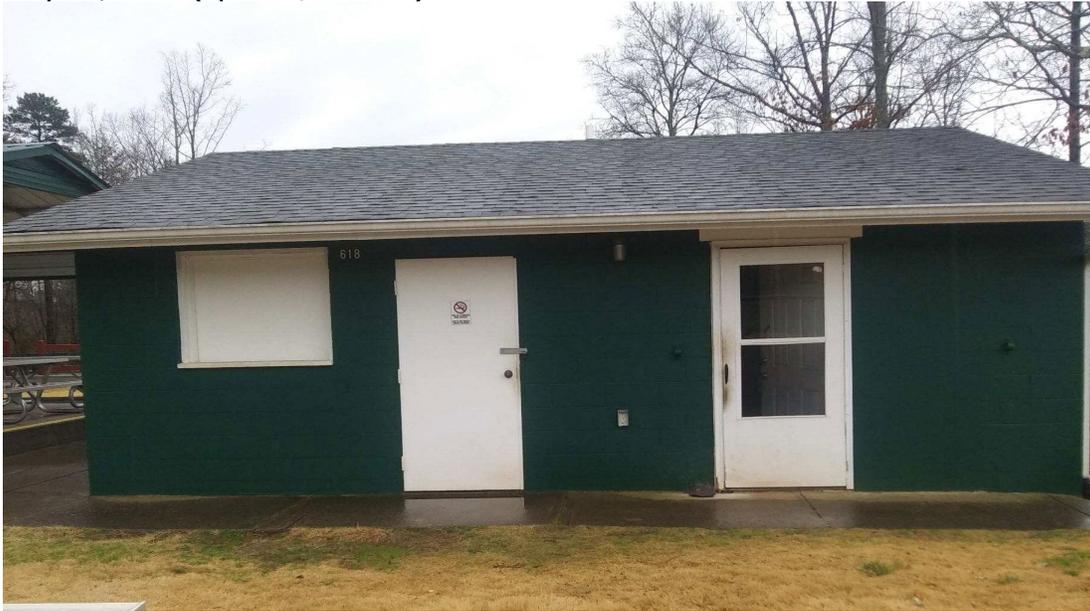
Name of park or trail area: Simpson Park

Known issues: Concession and bathrooms need overhauled

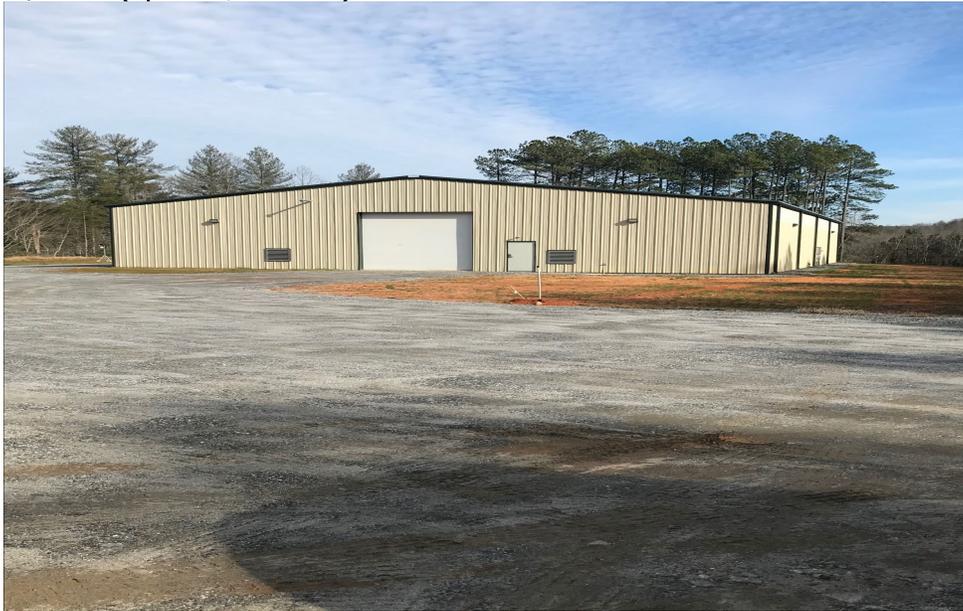
Name of Building: Emergency Management Storage
Address: 2500 Marsh Trail
Morganton, NC
REID # 42757, PIN # 2714597082

Known issues: No security fence/gate
No toilet facilities
Grass areas need stabilizing

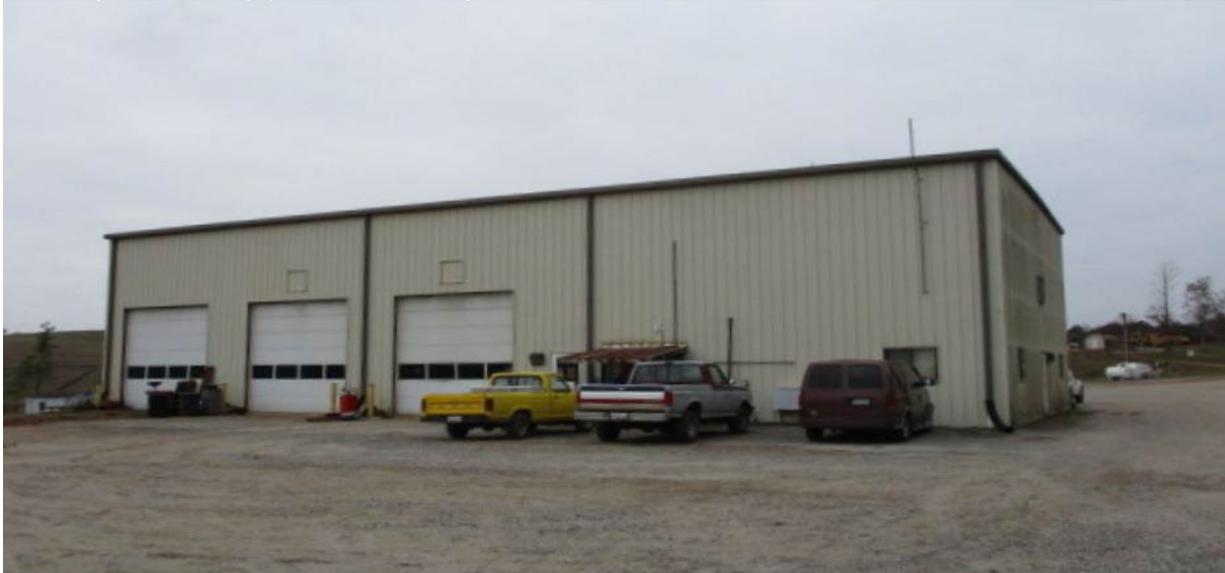
Name of Building: Landfill Garage
Address: 2500 Marsh Trail
Morganton, NC
REID # 42757, PIN # 2714597082

Known issues: Needs new roof

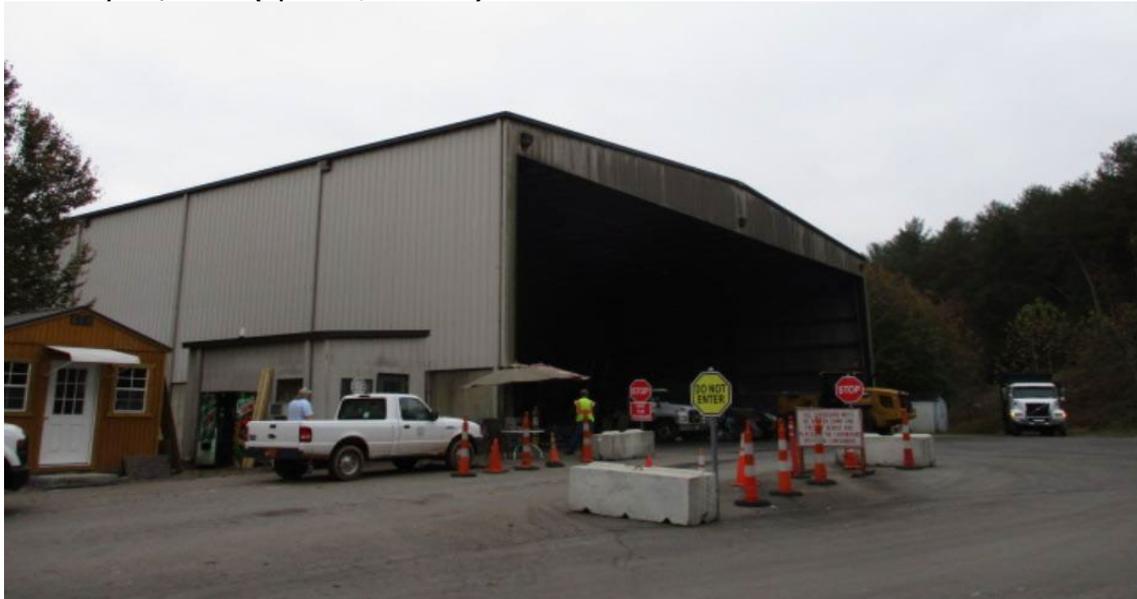
Name of Building: Landfill Transfer Station

| Landfill Transfer Station | Poor | <ul style="list-style-type: none"> • Significant concrete floor repairs are needed • Inadequate ventilation • Additional paving required for truck |

| | | <p>traffic and public safety</p> <ul style="list-style-type: none"> • Need better design and repair of transfer chutes • Replace Skylights • The entire building/operation needs to be reevaluated within five (5) years |
| <p>Discussion ensued regarding the landfill transfer station building, concrete floor, asphalt, and operational design. Mr. Champion said within five (5) years the entire configuration of the transfer station operation needs to be rebuilt, due to the age and poor condition of the building/transfer station area.</p> | | |

Known issues: Significant concrete floor repairs needed
Inadequate ventilation
Additional paving required for truck traffic and Public safety
Need better design of transfer chute
Replace Skylights

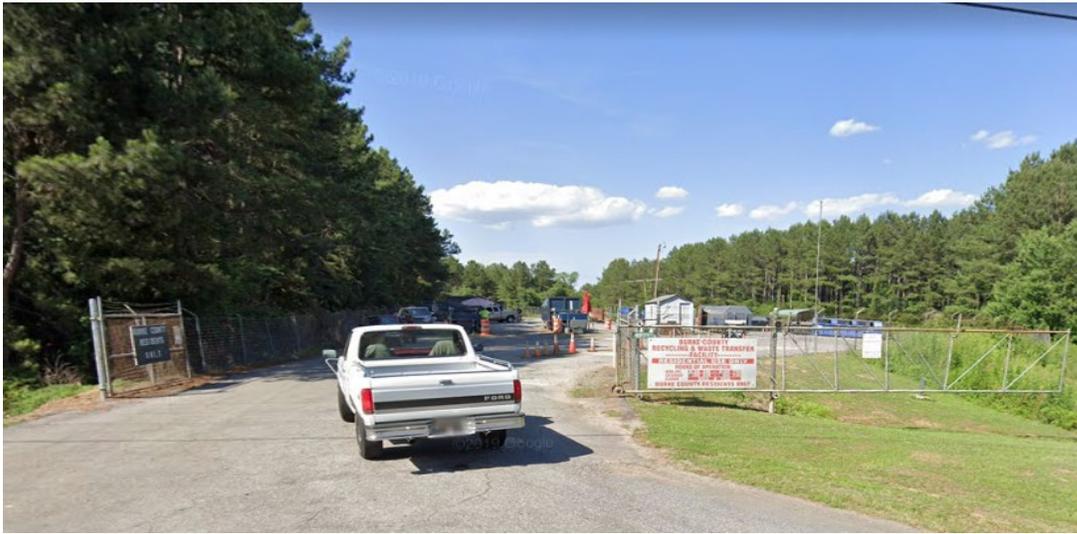
Name of Building: East Burke Convenience Center
Address: 8827 Rhodiss Rd.
Connelly Springs, NC
REID # 42758 PIN # 2774415996

Known issues: Site is sinking due to being constructed on
closed landfill
Continuous electrical issues
Building not worth renovating
Proposed site to relocate
