**MINUTES
BURKE COUNTY BOARD OF COMMISSIONERS
SPECIAL MEETING**

BURKE COUNTY, NORTH CAROLINA

PROPERTY BOOK

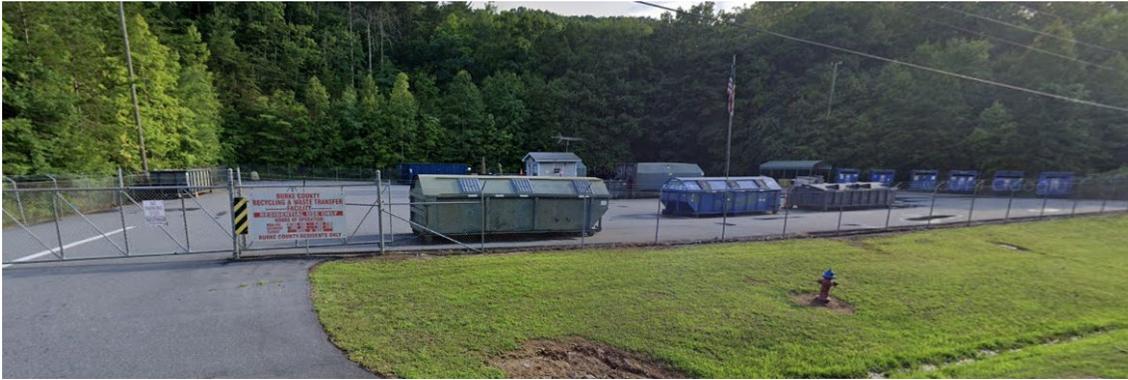
Name of Building: Hwy 18 S. Convenience Center
Address: 3836 Hwy 18 S.
Morganton, NC
REID # 7705 PIN # 2721198460

Known issues: No restrooms- to be constructed by June 2020

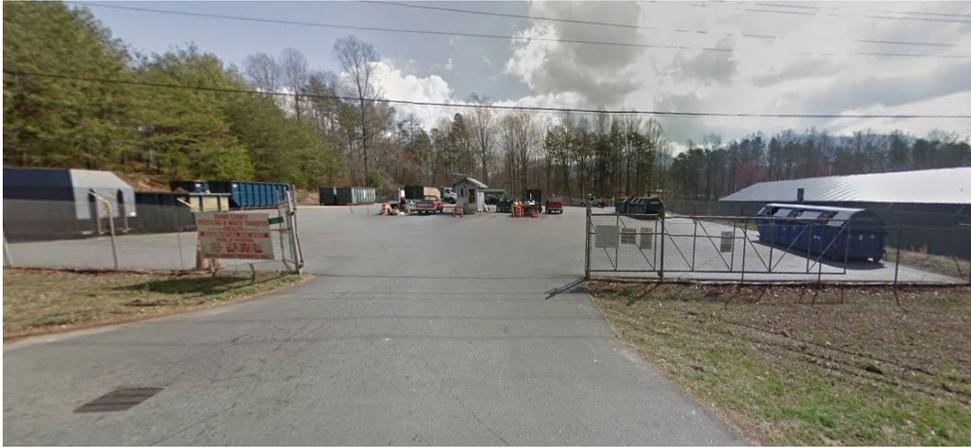
Name of Building: Hwy 64 South Convenience Center
Address: 3251 US 64
Morganton, NC
REID # 8780 PIN # 1781825618
.
Occupants: Site Attendant
Note if rent received

Known issues: Needs restroom
Needs painting
Needs roofing

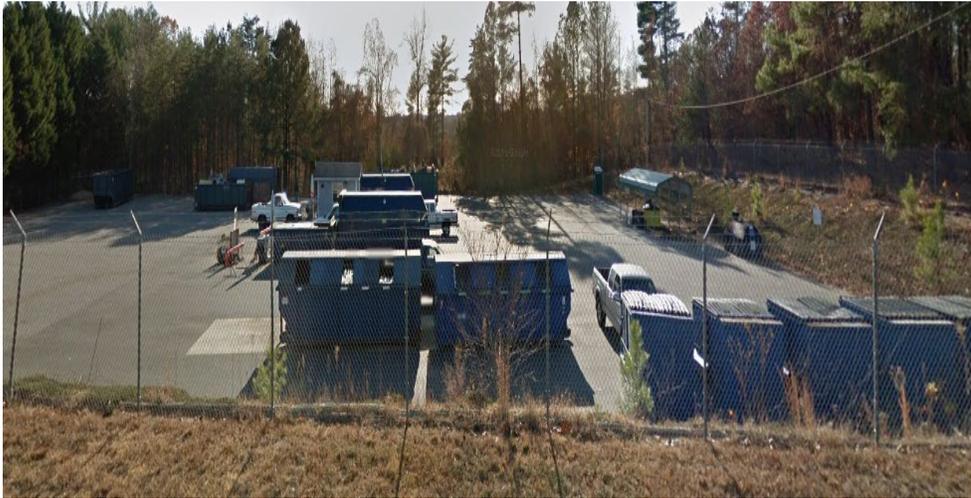
Name of Building: Hwy 126 Convenience Site
Address: 1679 NC 126
Morganton, NC
REID # 48719, PIN # 17747177860

Known issues: Needs paint interior/exterior

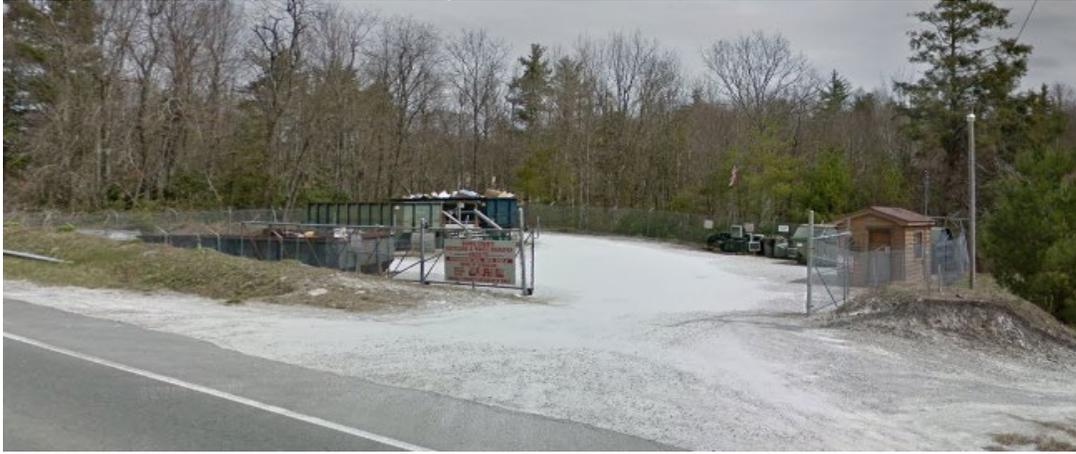
Name of Building: Jonas Ridge Convenience Site
Address: 8618 NC 181
Newland, NC

| Jonas Ridge Convenience Site | Average | <ul style="list-style-type: none"> • No renovations recommended • Site to move to new location in 1-2 years |

Known issues: Needs exterior Paint
