**MINUTES
BURKE COUNTY BOARD OF COMMISSIONERS
SPECIAL MEETING**

BURKE COUNTY, NORTH CAROLINA

PROPERTY BOOK

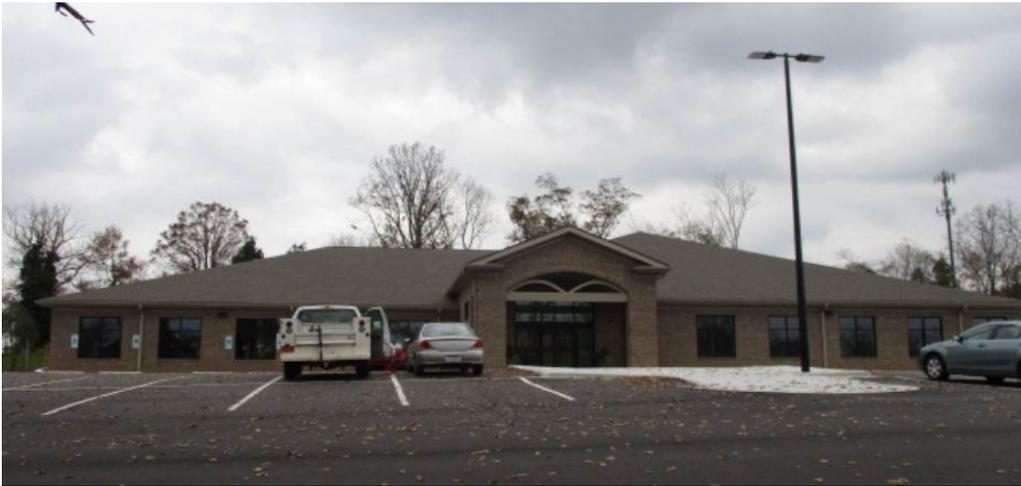
Name of Building: East Burke Library-Senior Center
Address: 101 Main Ave Hildebran
Hildebran, NC

Overall Building Condition: Good

Interior condition by floor: No issues to report

Parking lot condition: Good
